Impact Evaluation of Water Supply and Sanitation in Coastal Area Project (GOB-Danida)

June 2012

Impact Evaluation
of
Water Supply and Sanitation in Coastal Belt Project (GOB-Danida)

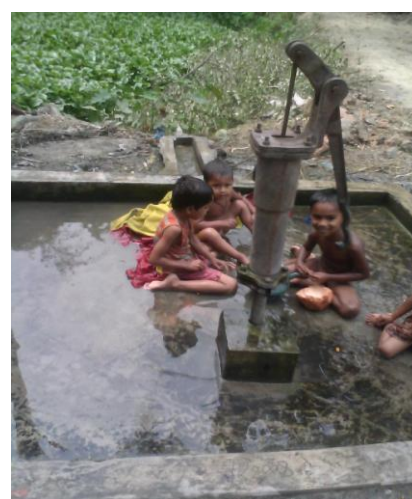
38. The enumerators observed 465 deep tube wells (DTW). Out of the observed deep tube wells 96% are operational and the rest 4% are out of order. All operational DTW have pumps and platforms, and water quality of 88% DTW was tested at the time of installation of tube wells. The DTW are located on generally the caretaker's land. However, in 68% DTW are located on caretakers' land and 10% on common public land, and 22% are on restricted areas with limited access of other users.

39. Out of the 465 DTW observed 448 are operational (96%) and the rest 4% are out of order for different reasons. Major reasons of non-operation of the DTW are temporary disorder of pump, poor water quality, disorder is irreparable, and pump is stolen. Reasons of non-operation of DTW are at table 3.8.

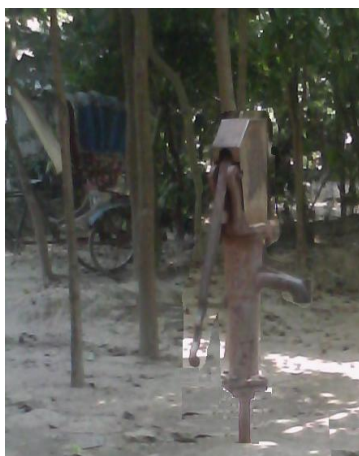
40. Condition of Platform: Conditions of bases of 100% deep tube were rigid. Most of the deep tube wells (86%) have platform, platform and surroundings are clean with 80% DTW. Conditions of platforms are good for 85% DTW, broken for 4% DTW, and water logged in 10% DTW. Details of the conditions of platform are at table 3.9.

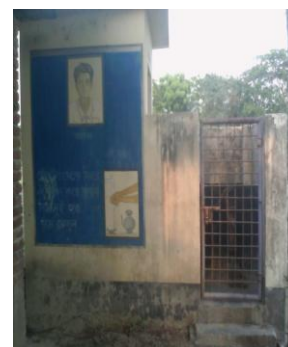
58. The enumerators observed 32 community latrines. The types of latrines were: pan with water seal (20%), pan without water seal (2%), offset latrine (6%), and latrine with septic tank (4%). There were two units of most of the observed latrines and having separate unit for male and female. Most of the latrines (84%) are useable conditions and the rest are un-useable. The reasons of being unserviceable are: pits are filled up; pans are filled up, dirty, damaged by floods and rain water, and difficulty climbing up and getting down the latrines. Details are at table 3.27.
